Assessment of Dam Safety of Coal Combustion Surface Impoundments

Indianapolis Power & Light Company

Eagle Valley Generating Station

Draft Report

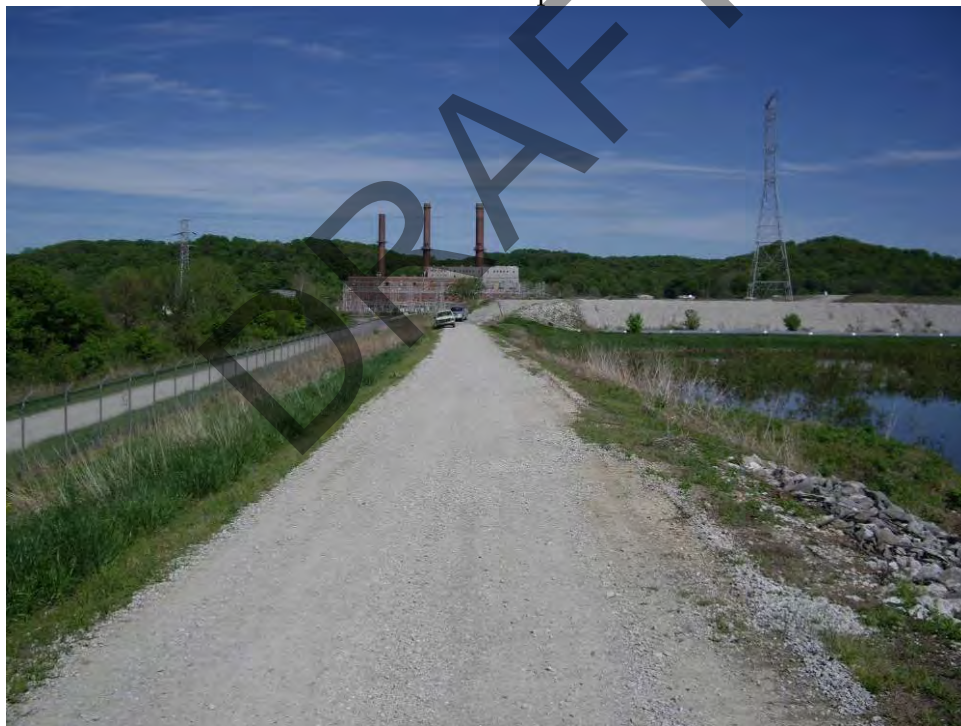
48. Pond C – North embankment crest, looking east.

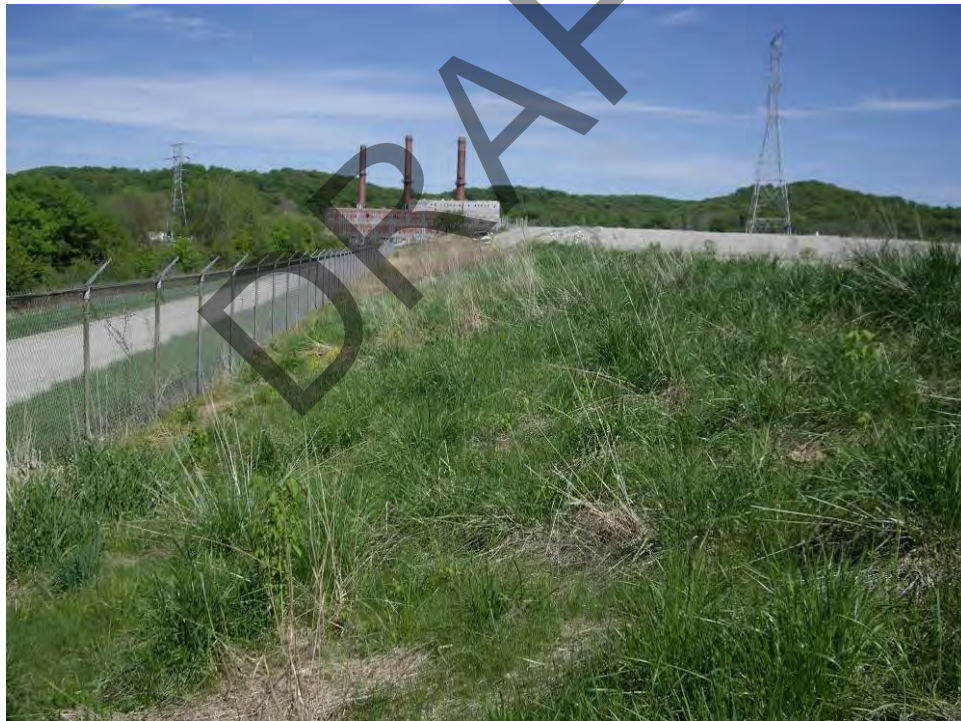
50. Pond C - North embankment exterior slope, looking east.

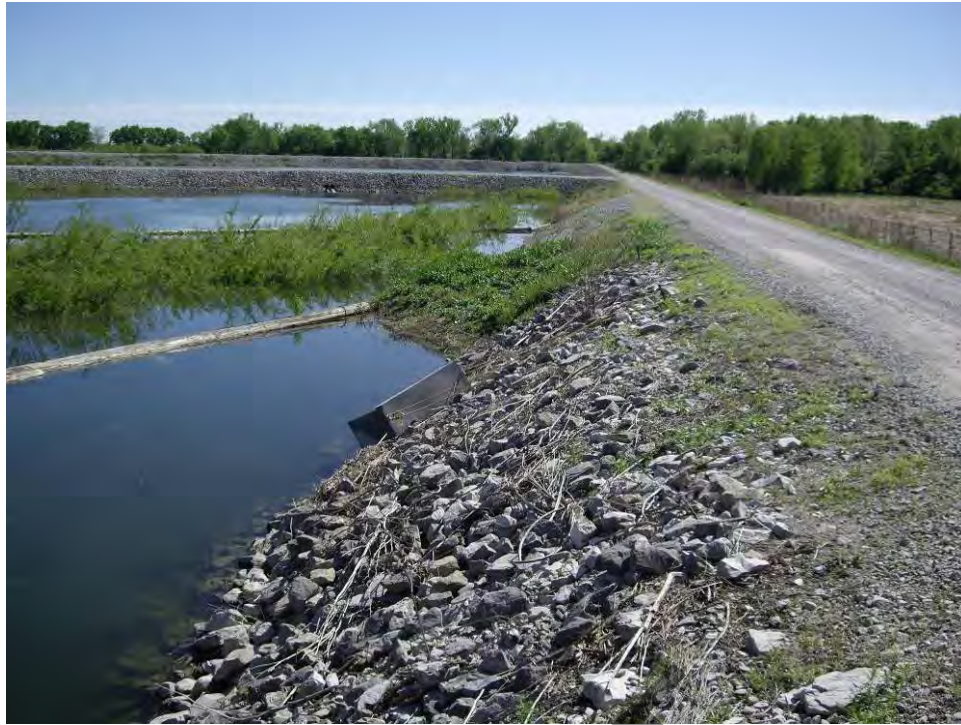
51. Pond C - West embankment interior slope, looking south.

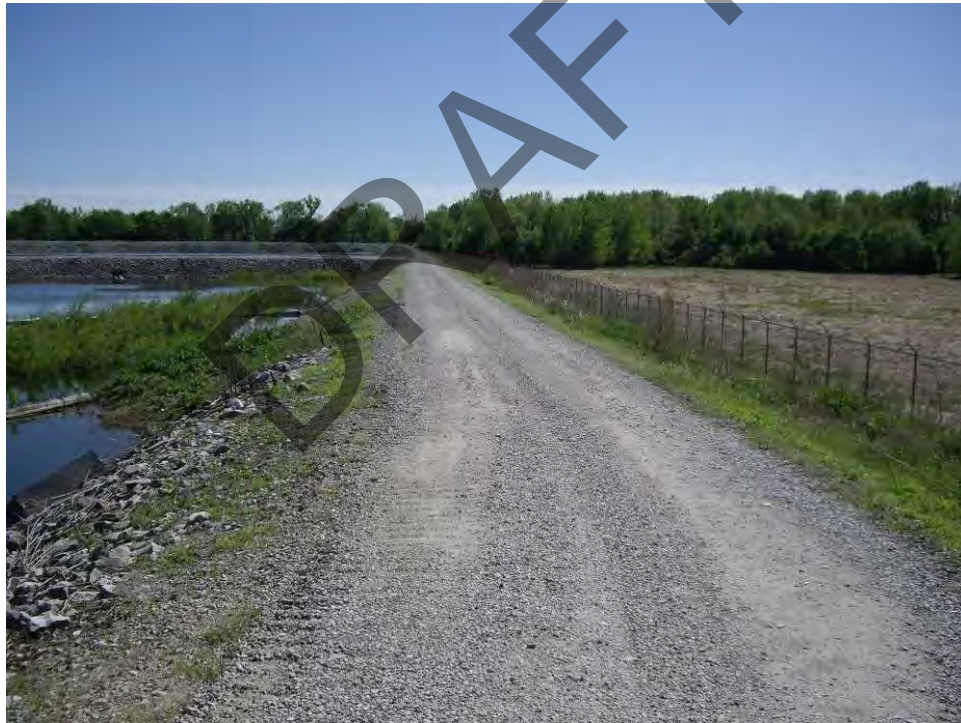
52. Pond C - West embankment crest, looking south.

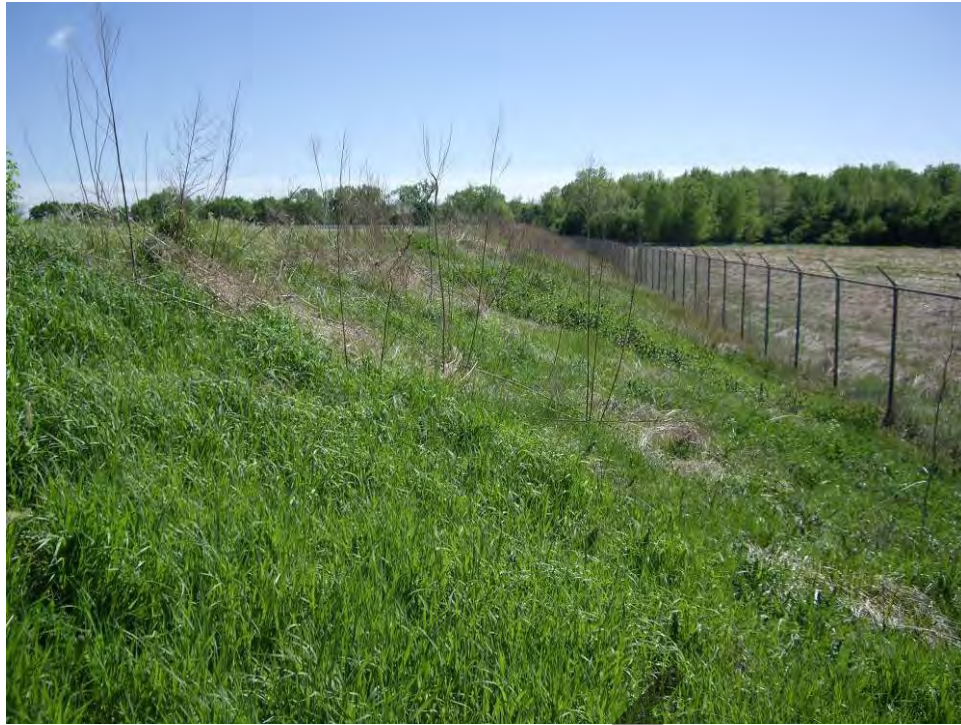
53. Pond C – West embankment exterior slope, looking south.

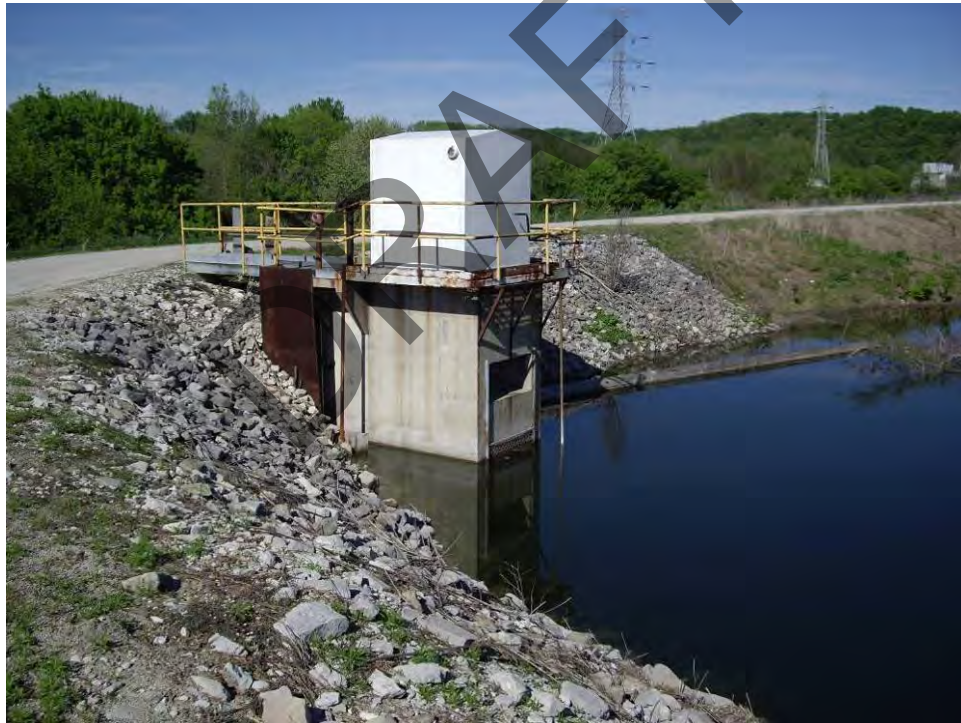
54. Pond C – Outlet structure gatehouse. Note stoplogs and butterfly valve in catwalk.

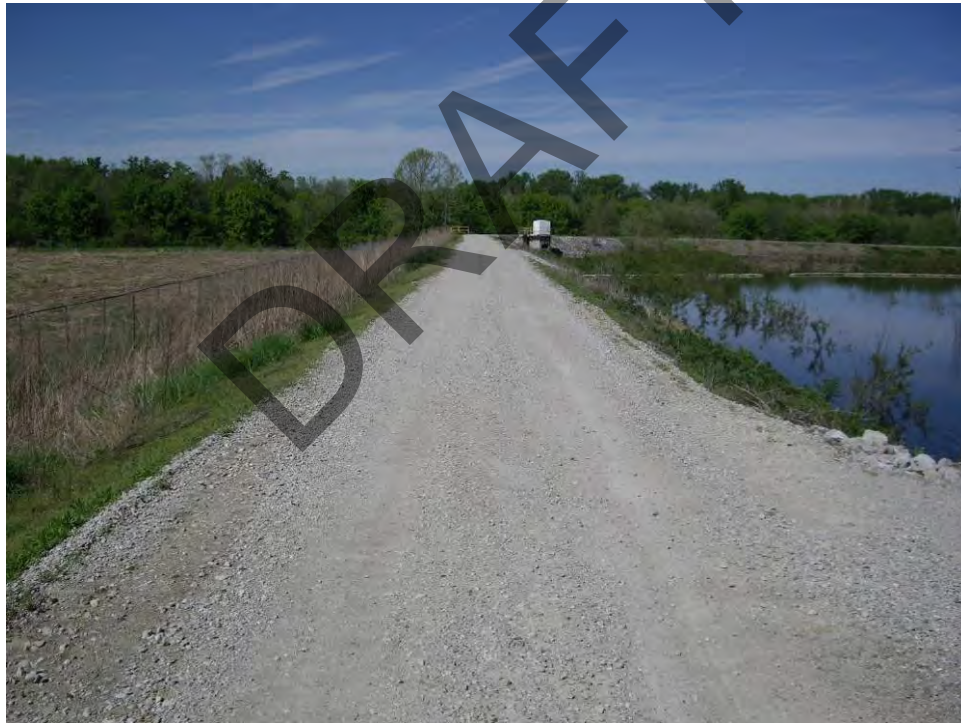
56. Pond C - West embankment crest, looking north

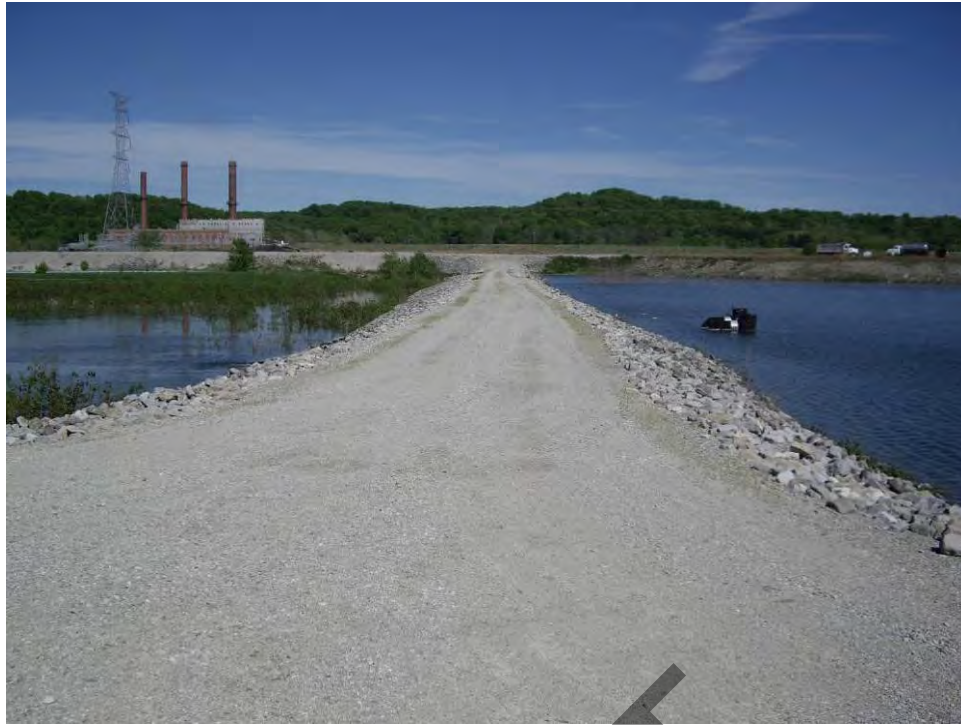
57. Crest of divider embankment B/C, looking east.

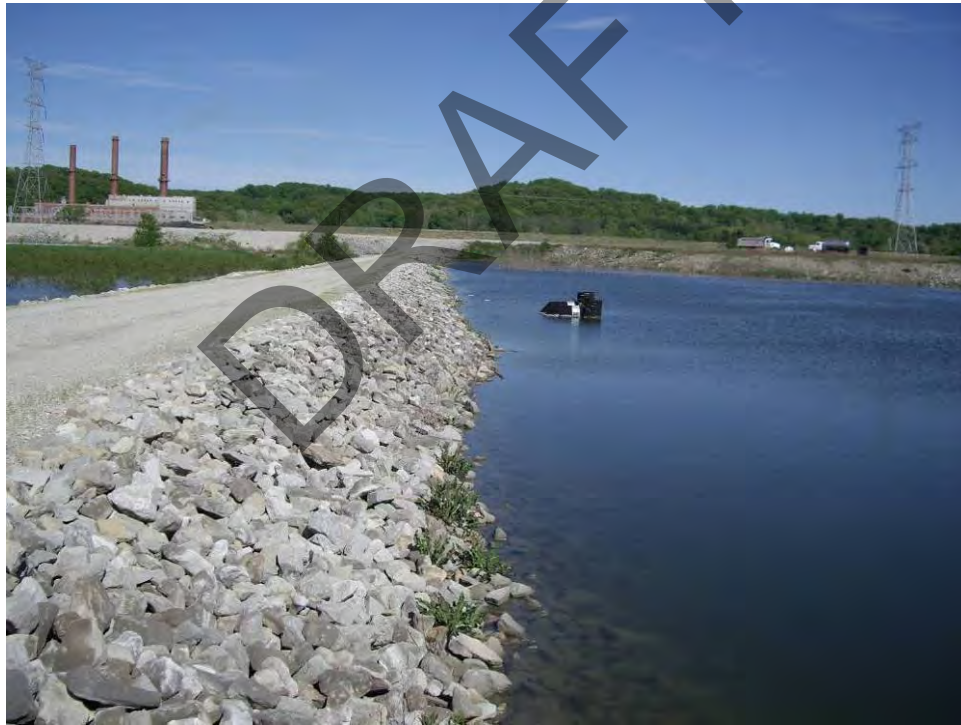
58. South slope of divider embankment B/C, looking east.

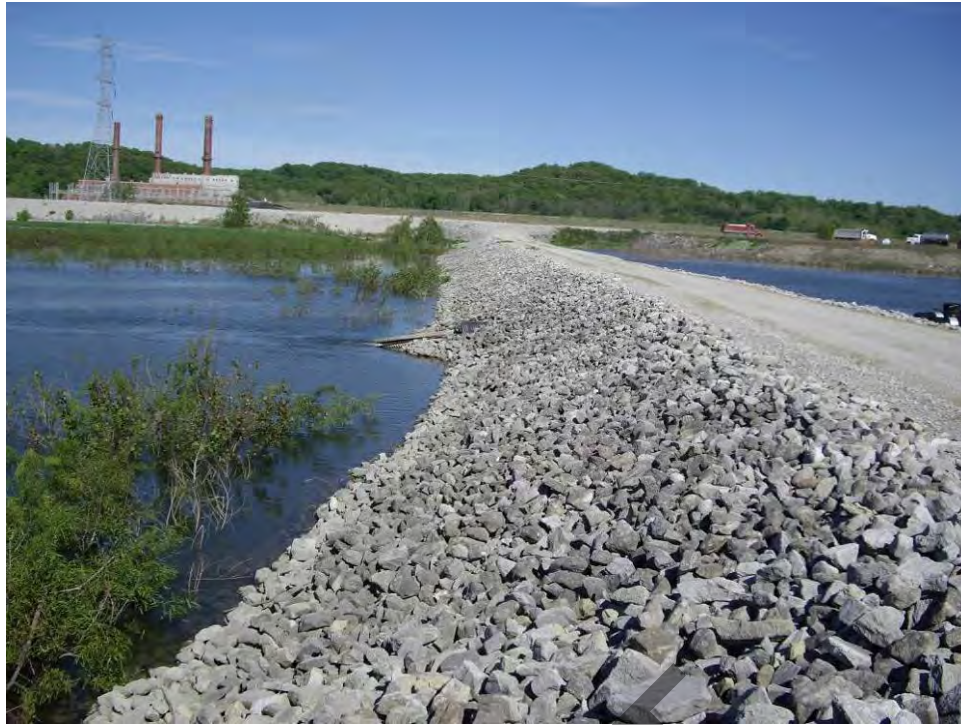
59. North slope of divider embankment B/C looking east.

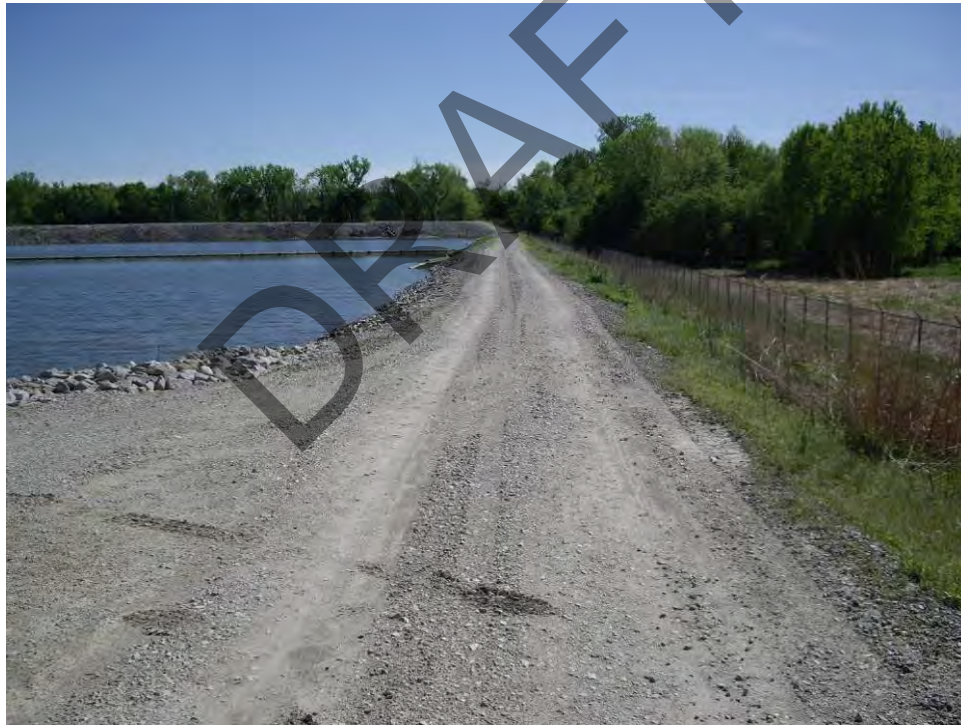
60. Pond B – west embankment crest, looking south.

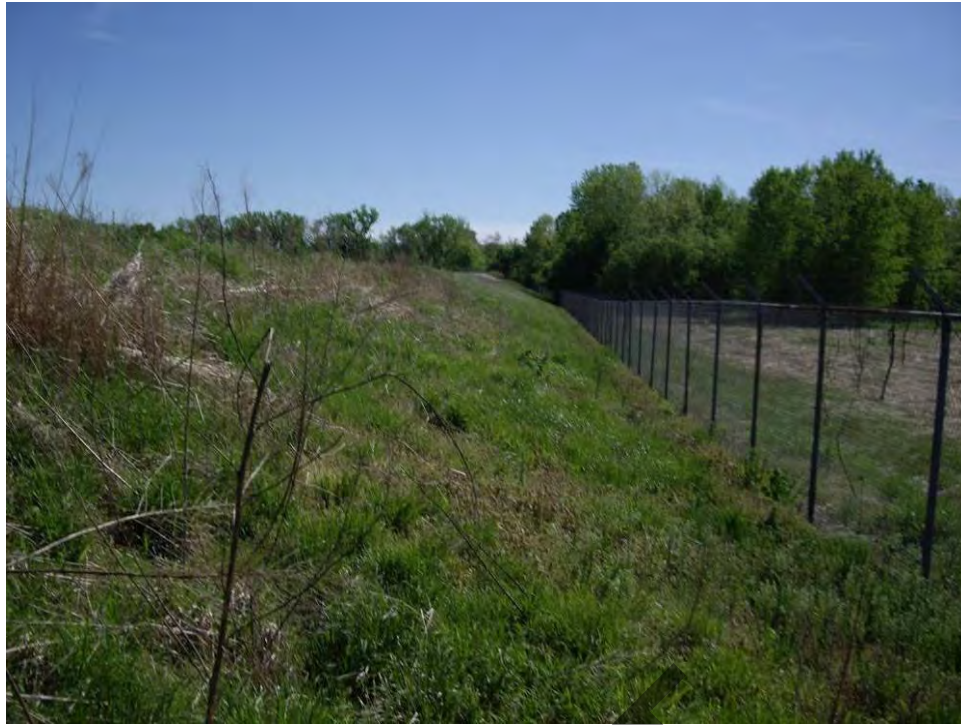
61. Pond B – west embankment exterior slope, looking south.

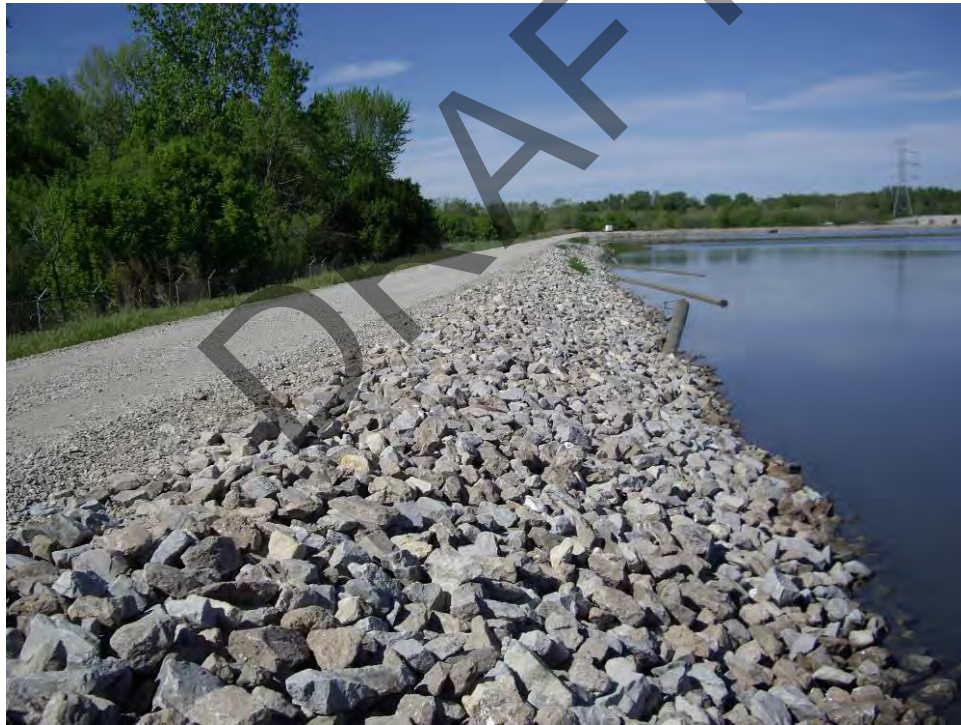
62. Pond B – west embankment interior slope, looking north

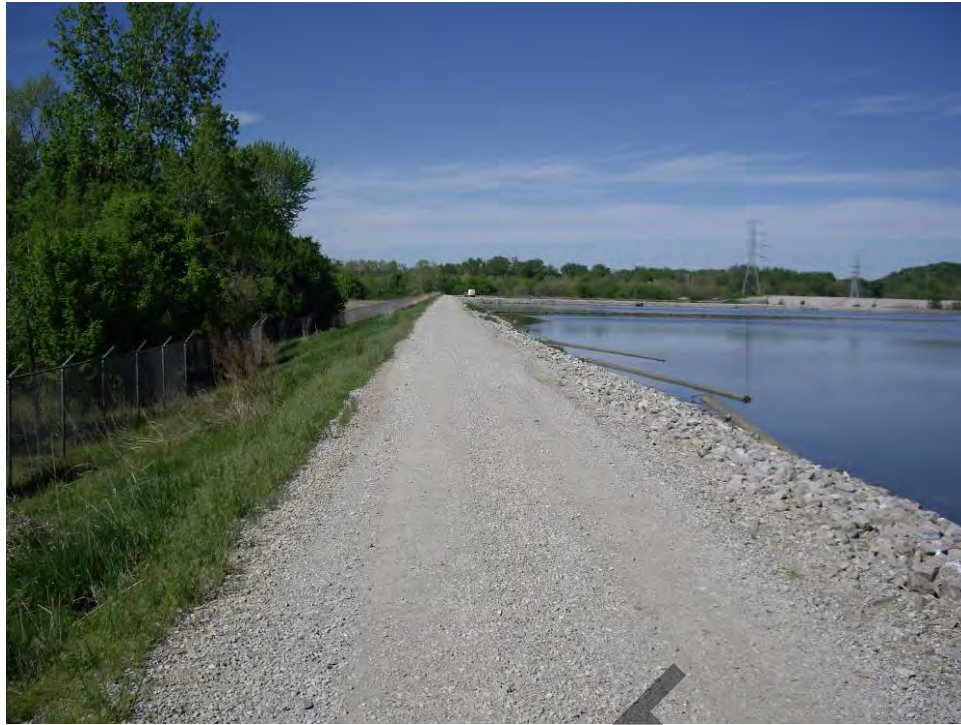
63. Pond B – west embankment crest, looking north

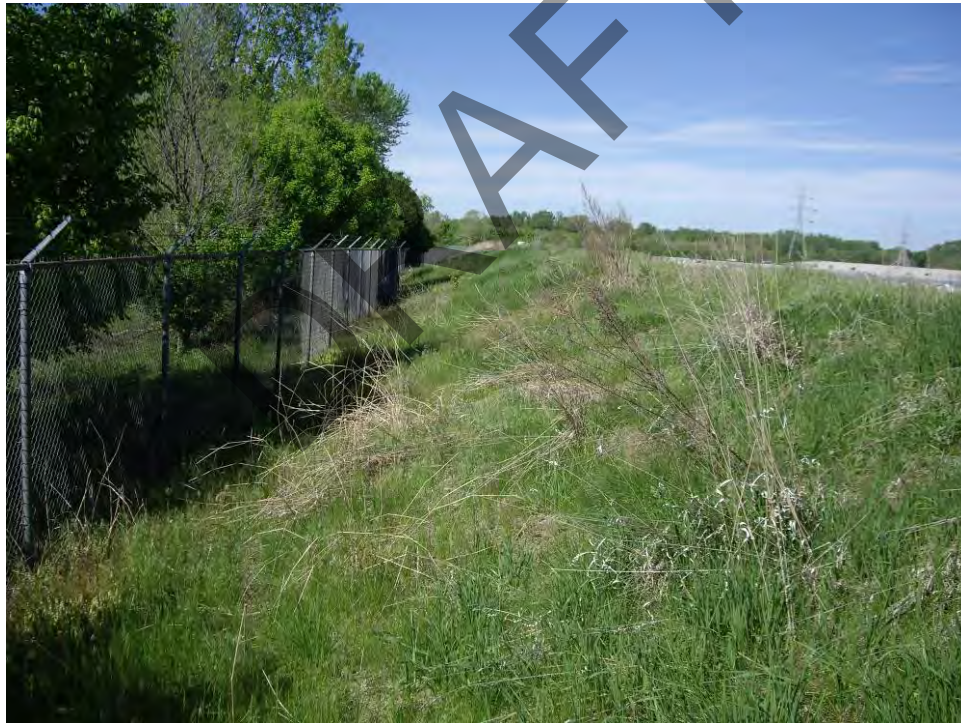
64. Pond B – west embankment exterior slope, looking north

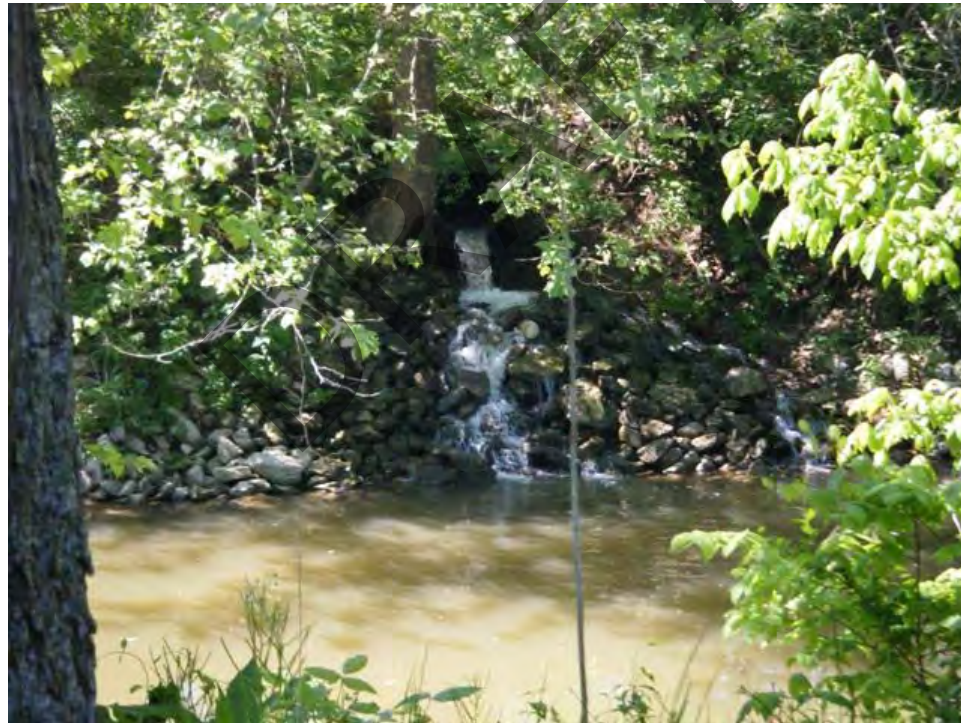
66. Pond C - Outlet structure outfall to discharge canal, looking south.

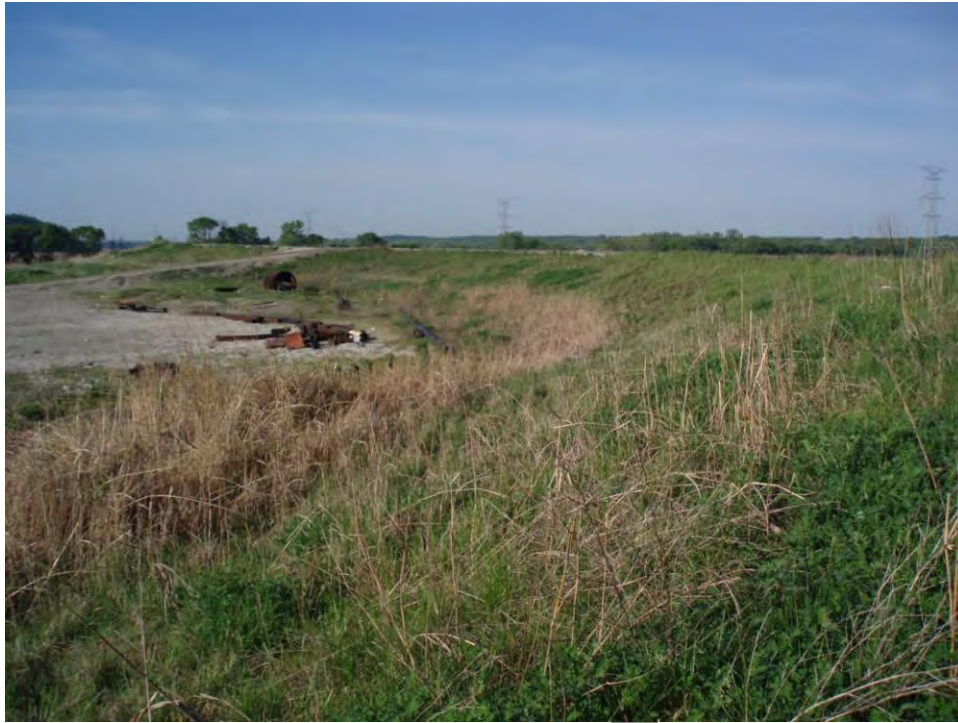
67. Pond D – east embankment exterior slope, looking southwest.

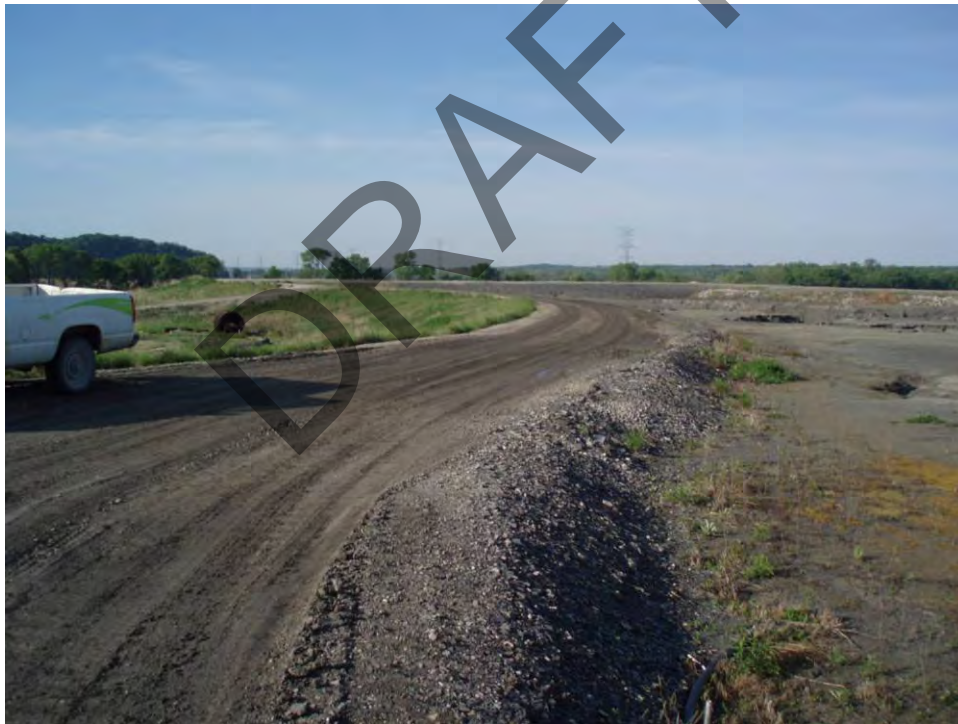
68. Pond D – east embankment crest, looking southwest.

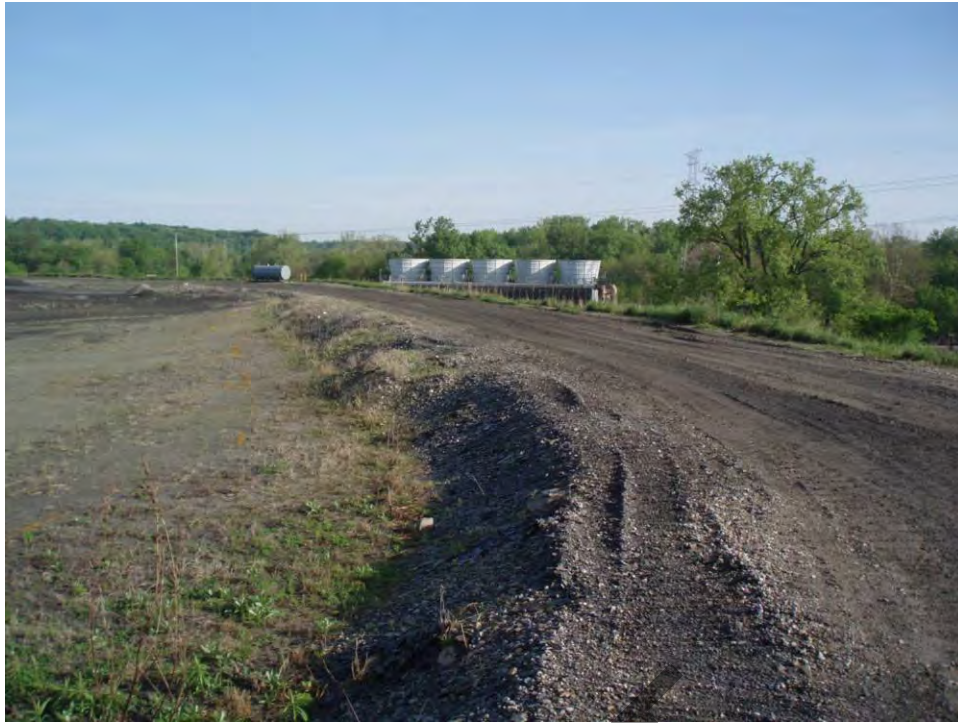
69. Pond D - north embankment crest, looking northwest.

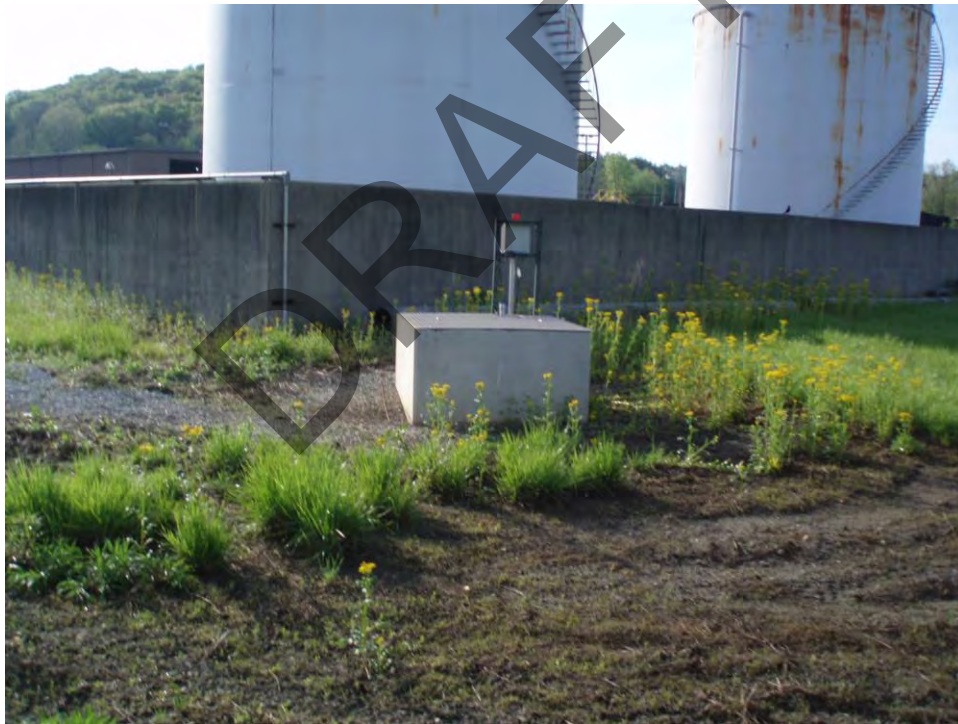
70. Pond D - north embankment toe drain sump pit located in northeast downstream area.

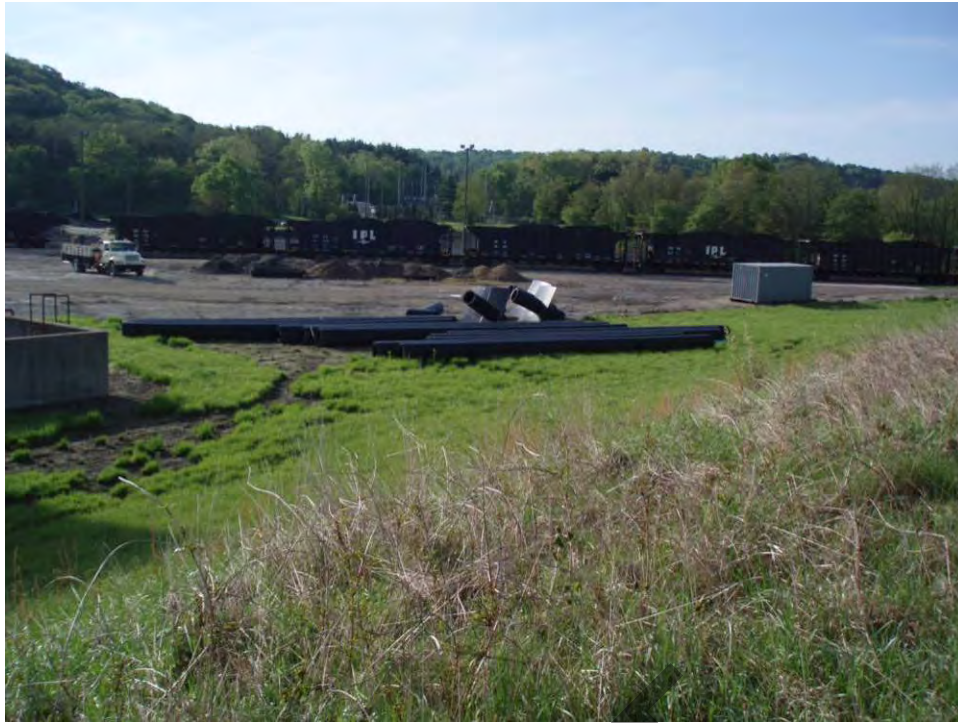
71. Pond D – East embankment downstream area looking southeast. Note new piping for Ponds D & E.

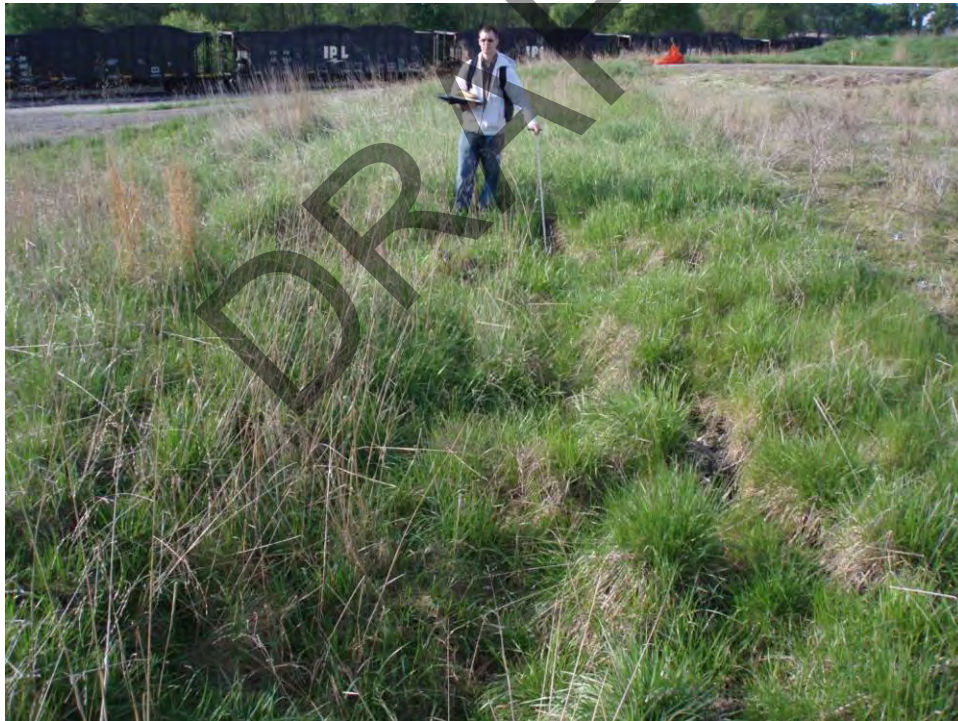
72. Pond D – Erosion rill and depression on east embankment buttress berm, looking south.

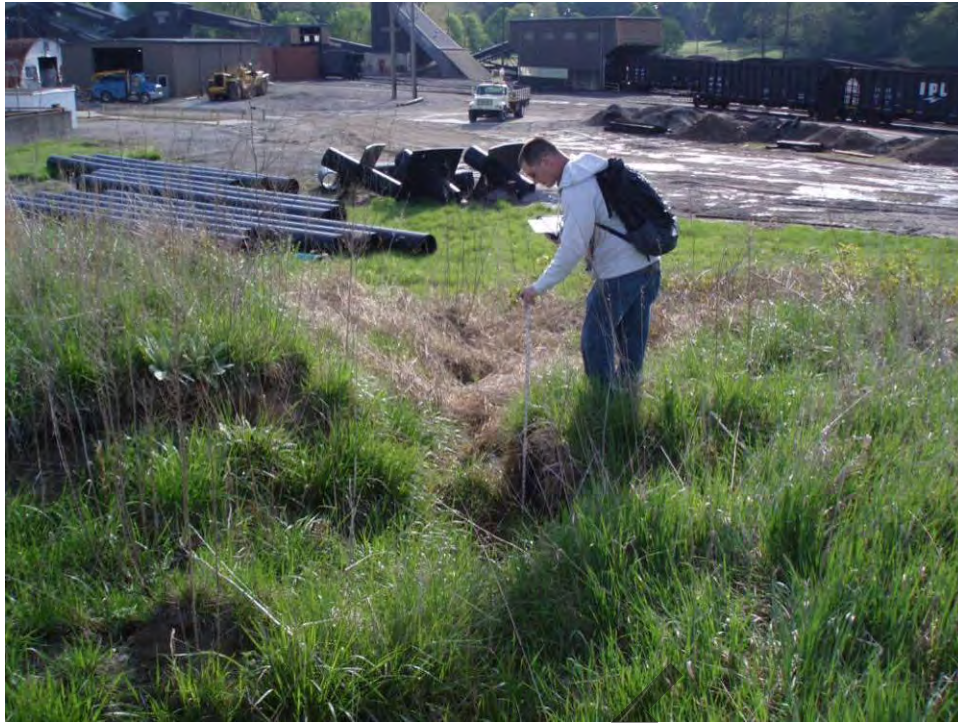
73. Pond D – Erosion rill on east embankment buttress berm, looking northeast

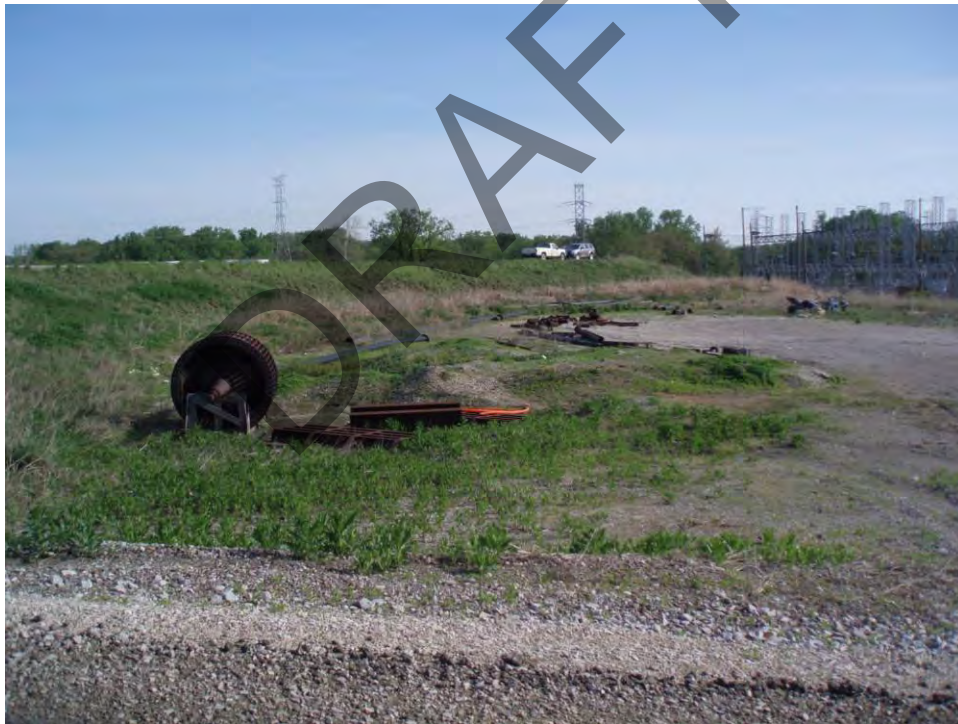
74. Pond D – Crest of east embankment buttress berm, looking north

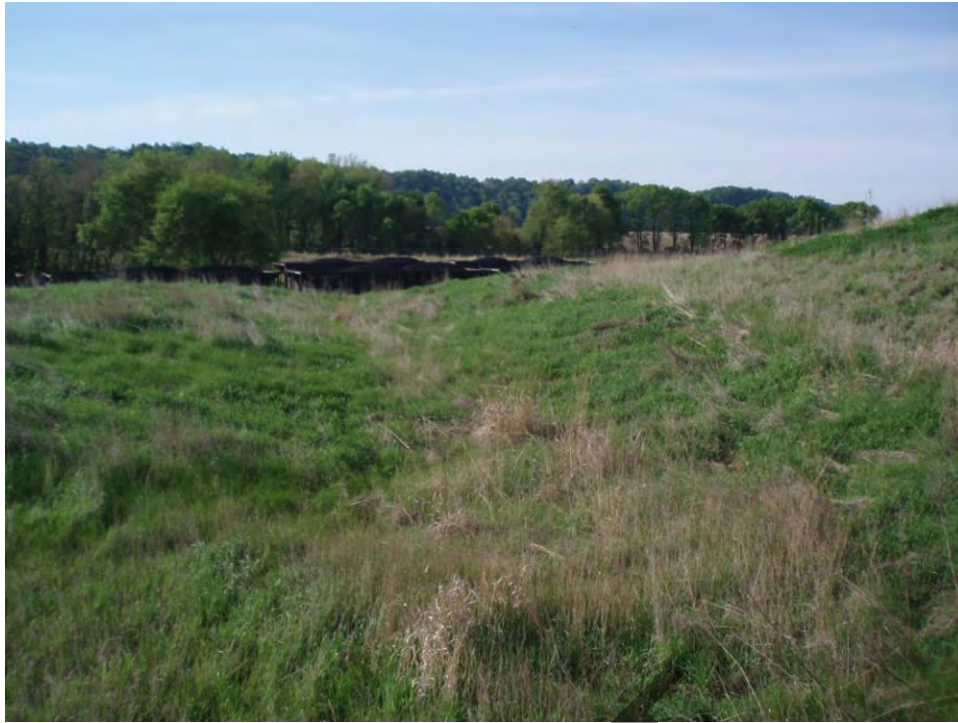
75. Pond D – Crest of east embankment buttress berm, looking south

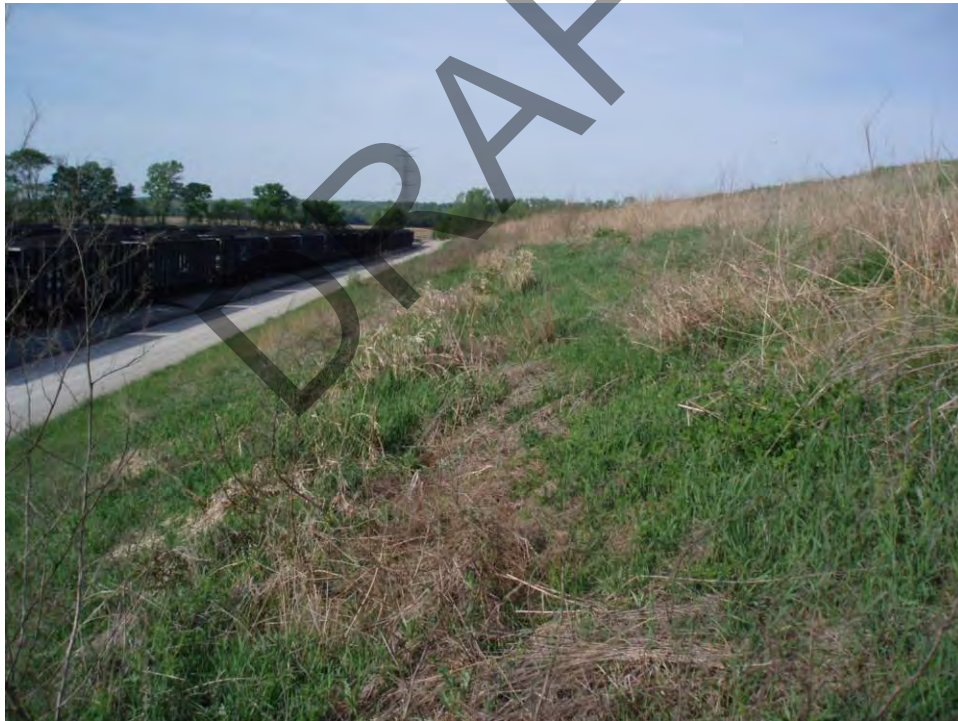
76. Pond D – Southeast embankment exterior slope, looking southwest.

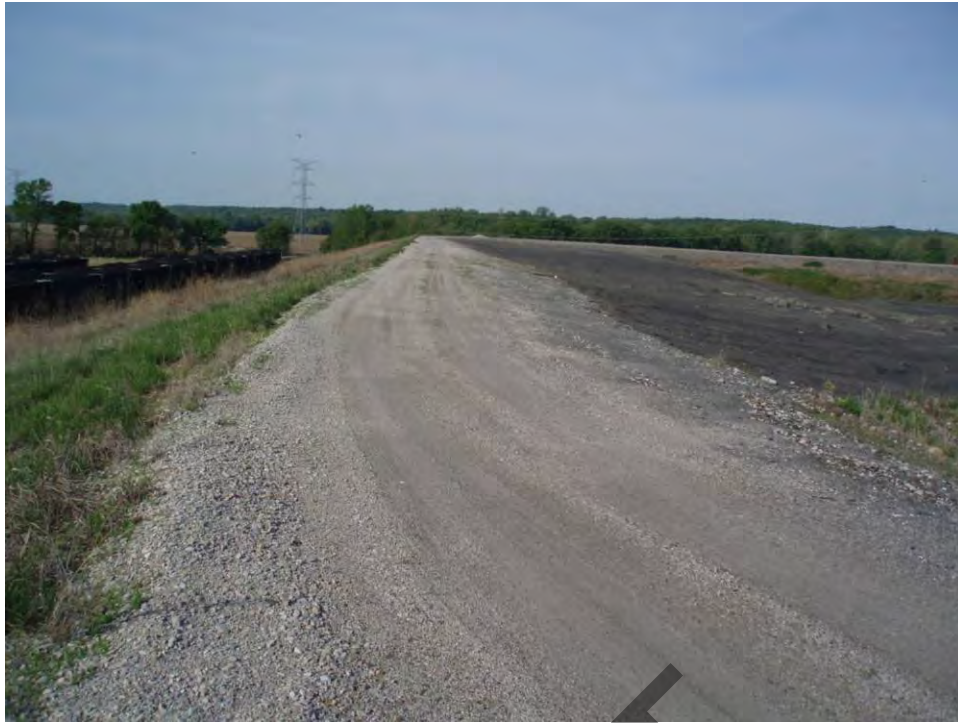
77. Pond D - Southeast embankment crest, looking southwest.

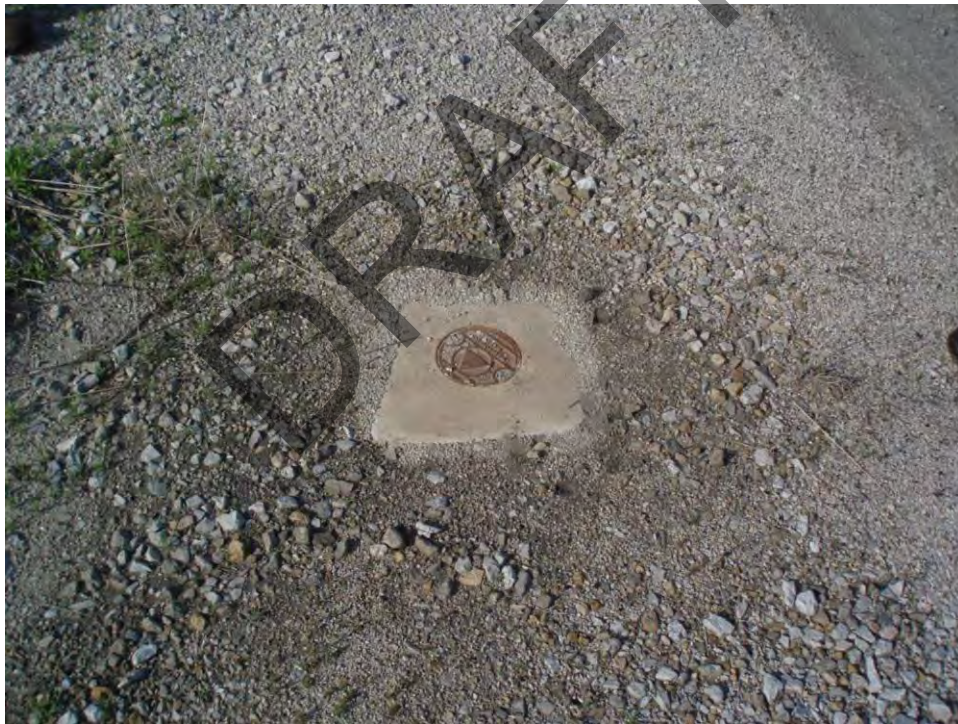
78. Piezometer PZ-2 on Pond D east embankment crest installed by BT² on 6/12/08.

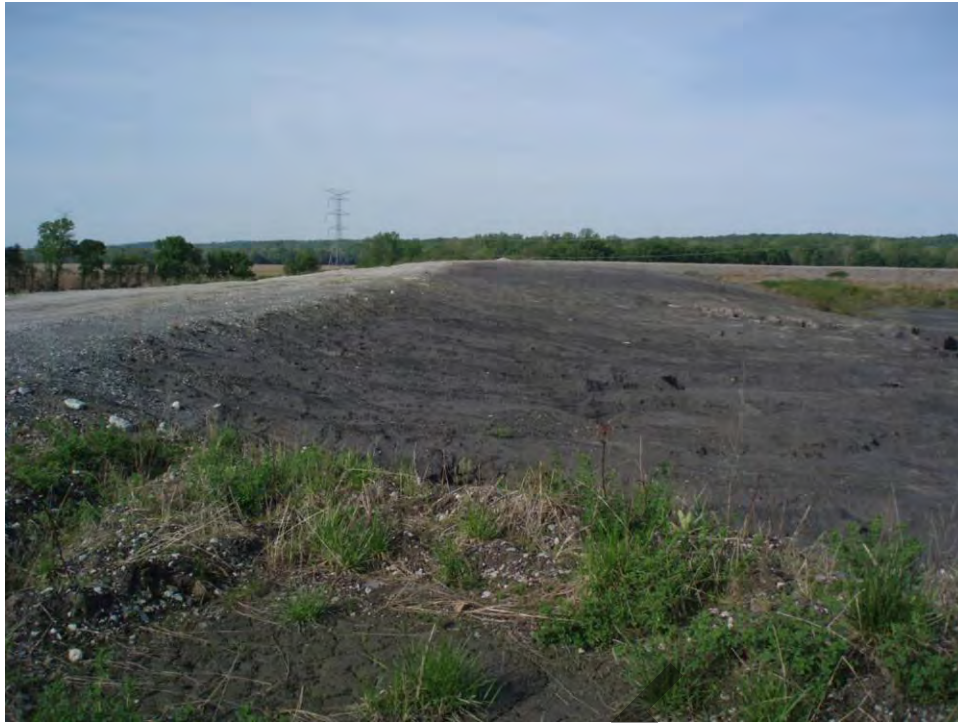
79. Pond D – Southeast embankment interior area, looking southwest

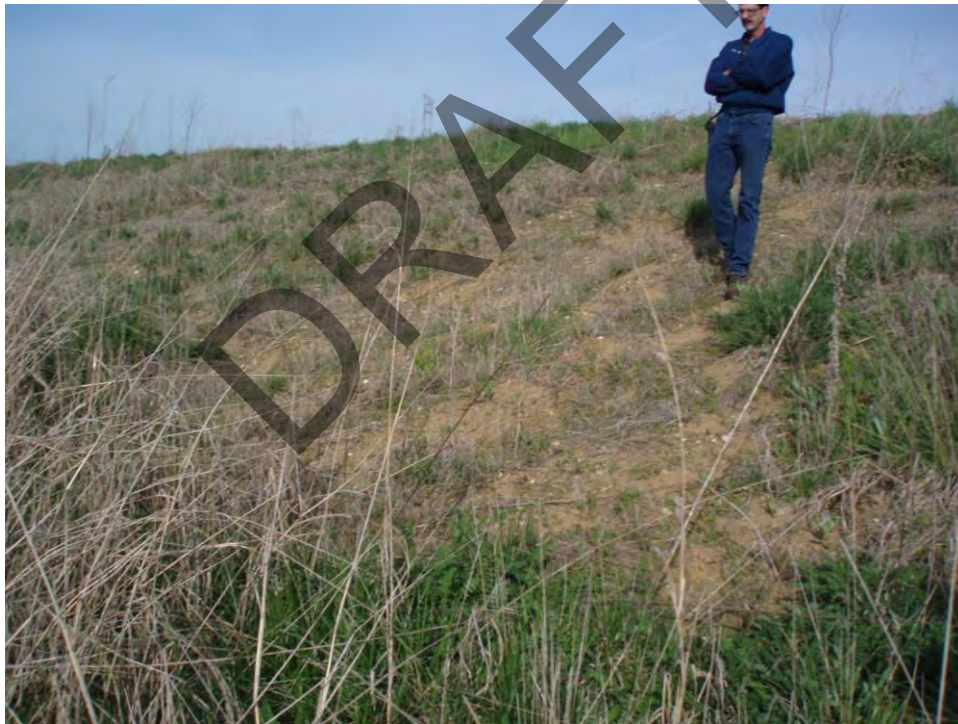
80. Pond D - Large bare spot on upper third of southeast embankment exterior slope, looking northwest.

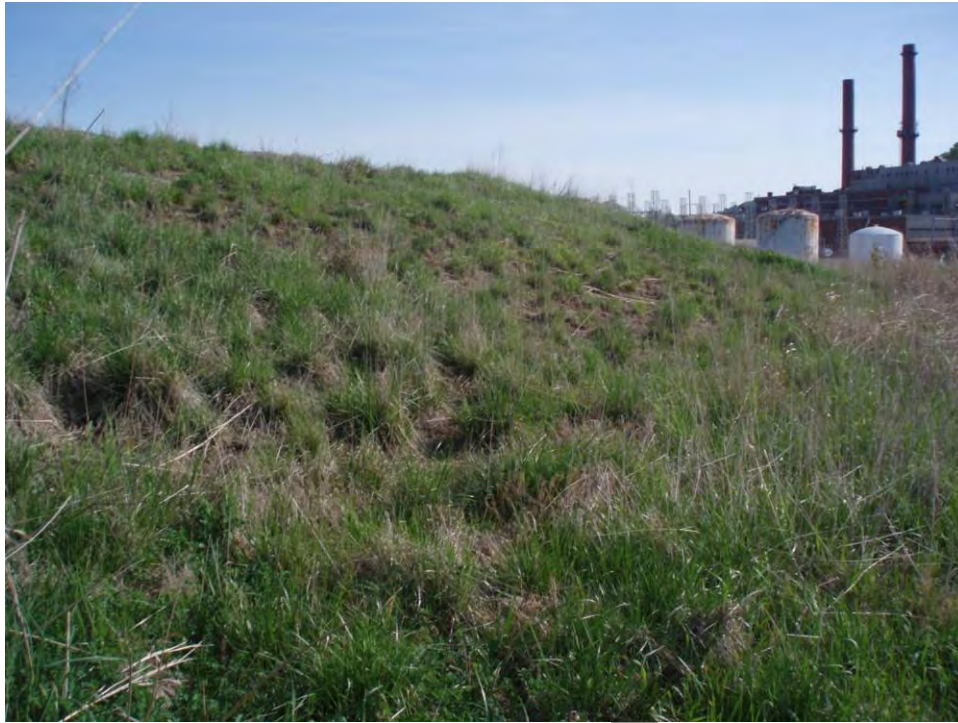
81. Typical bare spots on upper third of Pond D exterior embankment (last expansion).

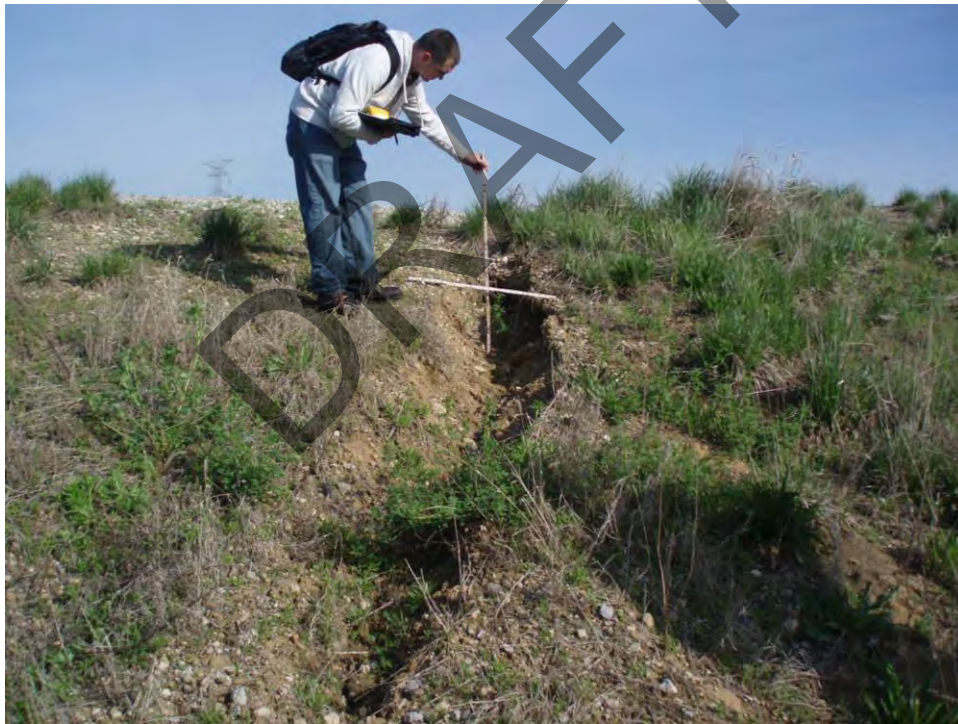
82. Pond D - Erosion rill on southeast embankment exterior slope, looking northwest.
